SCC Initiation Research on Alloy 600 and Alloy 690: PNNL Presentations at the EPRI Alloy 690 Expert Meeting

Milestone: M3LW-16OR0402032

Stress Corrosion Crack Initiation of Alloy 600

SCC Initiation Research on Cold-Worked Alloy 690: Grain Boundary Creep Cavities and IGSCC Precursors

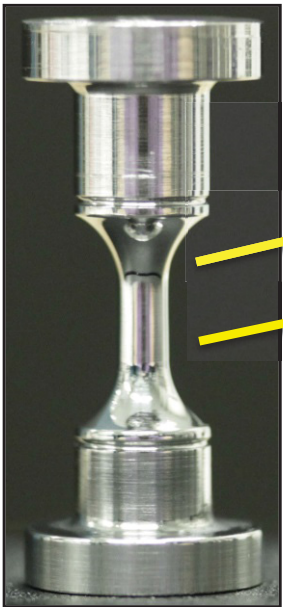
**1.2" Tall SCC
Initiation Specimen**

- *Based on PNNL SCC CGR test systems.*
- *Two systems that can test up to 6 specimens.*
- *One 36 specimen system with up to 20 specimens instrumented for initiation.*
- *All use DCPD for in-situ detection of crack initiation.*

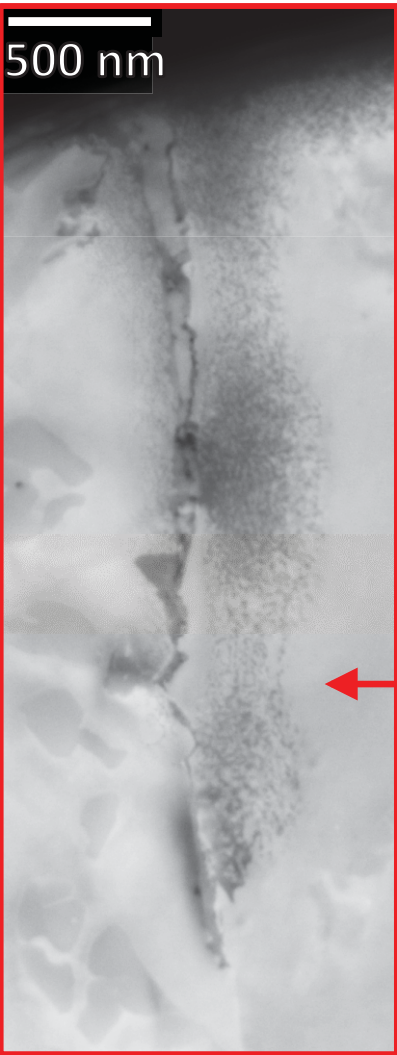
Blunt Notch – Typical Crack Morphology on Cross-Section (C707, 21%CF Valinox CRDM)

Largest crack:
Depth $\sim 3\ \mu\text{m}$

- Small, shallow IG cracks identified to depths $< \sim 3\ \mu\text{m}$.
- Creep cavities were observed ahead of some crack/oxidation tips.
- Creep cavities were also found close to the notch surface along some intact grain boundaries.

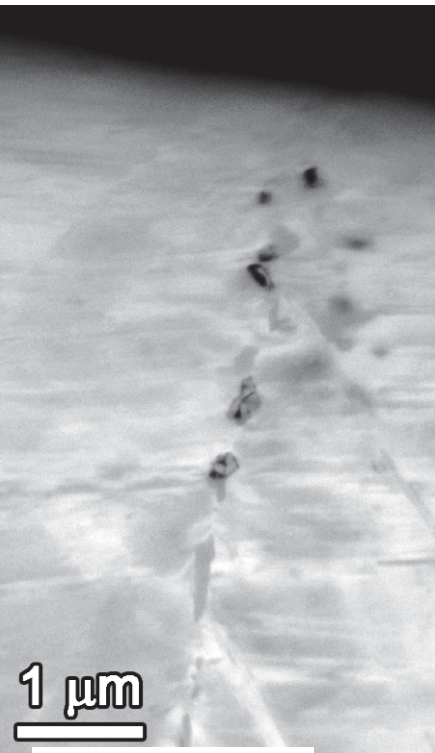
Blunt Notch C704, 31%CF Sumitomo CRDM – Near-Surface Grain Boundary Microstructures

- Creep cavities were very found close to the notch surface along a number of grain boundaries without evidence of IG crack nucleation.

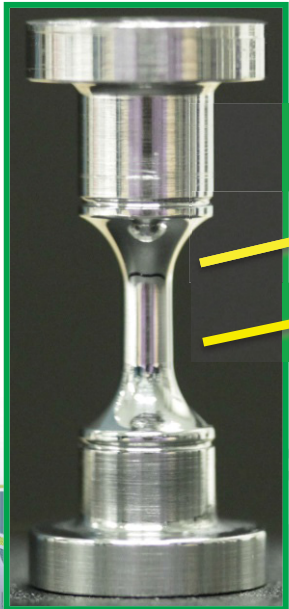
**1.2" Tall SCC
Initiation Specimen**

Two high-temperature, high-pressure autoclave systems with 6 fully instrumented specimens and one system for 36 specimens with up to 20 instrumented.
